Plidco Special Split-Oversleeve to seal off a leaking 1-1/2" "Y" valve, operating at 450° F., 450 psi working pressure.

## SPECIAL PLIDCO® REPAIR CLAMP FOR LEAKING WELLHEAD

## Utility Retains Customer Goodwill By Repairing Gas Leak On-Stream

# Gas Leak Repairs Without Shutdown

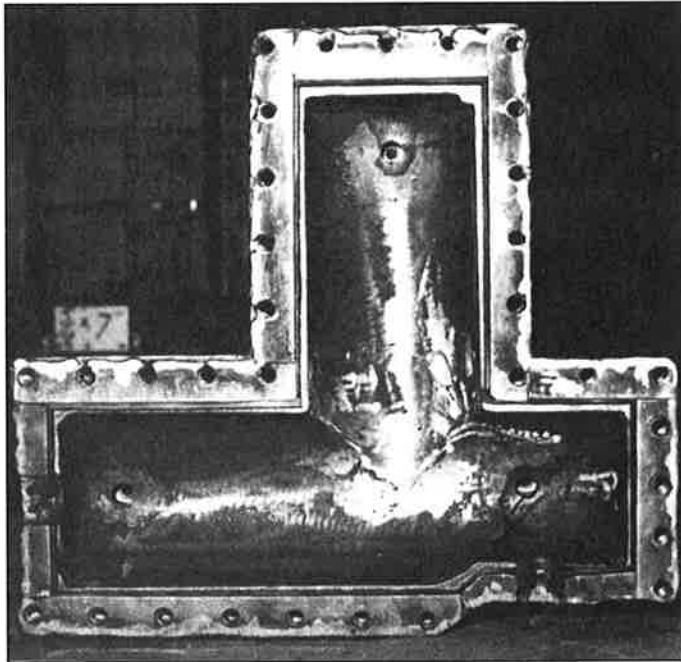
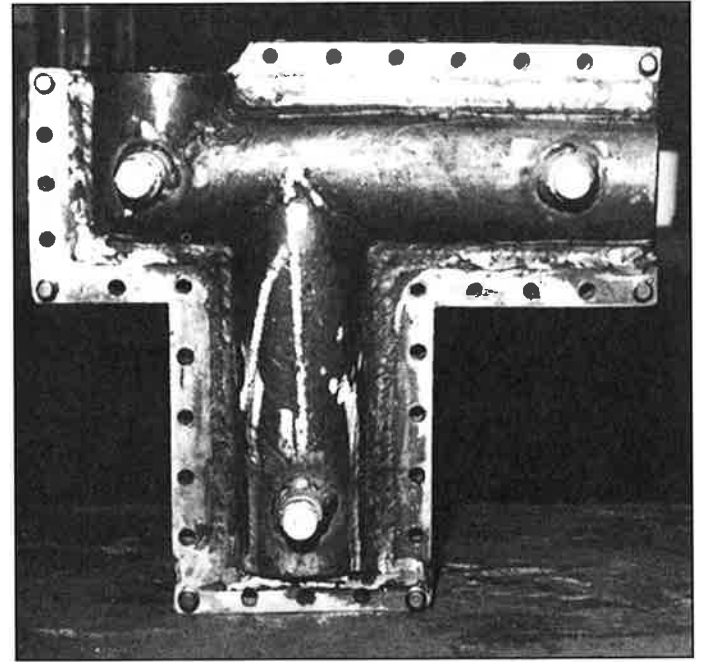
Plidco Special Split-Oversleeve to seal off a leaking 1/2" union, a 90° ell and a gate valve, operating at 450° F., 450 psi working pressure.

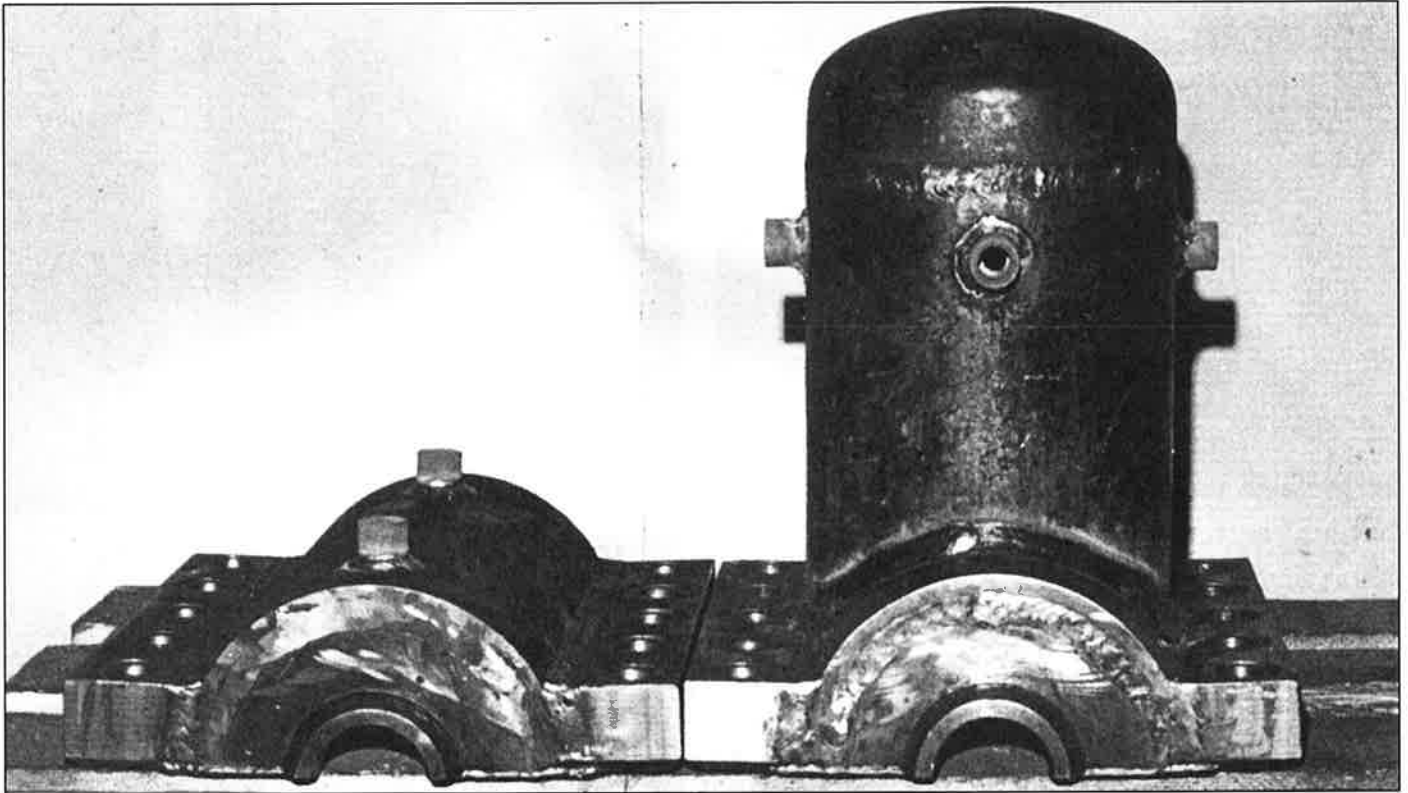
Plidco Special Oversleeve for a 2" 150# valve operating at 250 psig working pressure, steam service, it completely enclosed leaking valve.

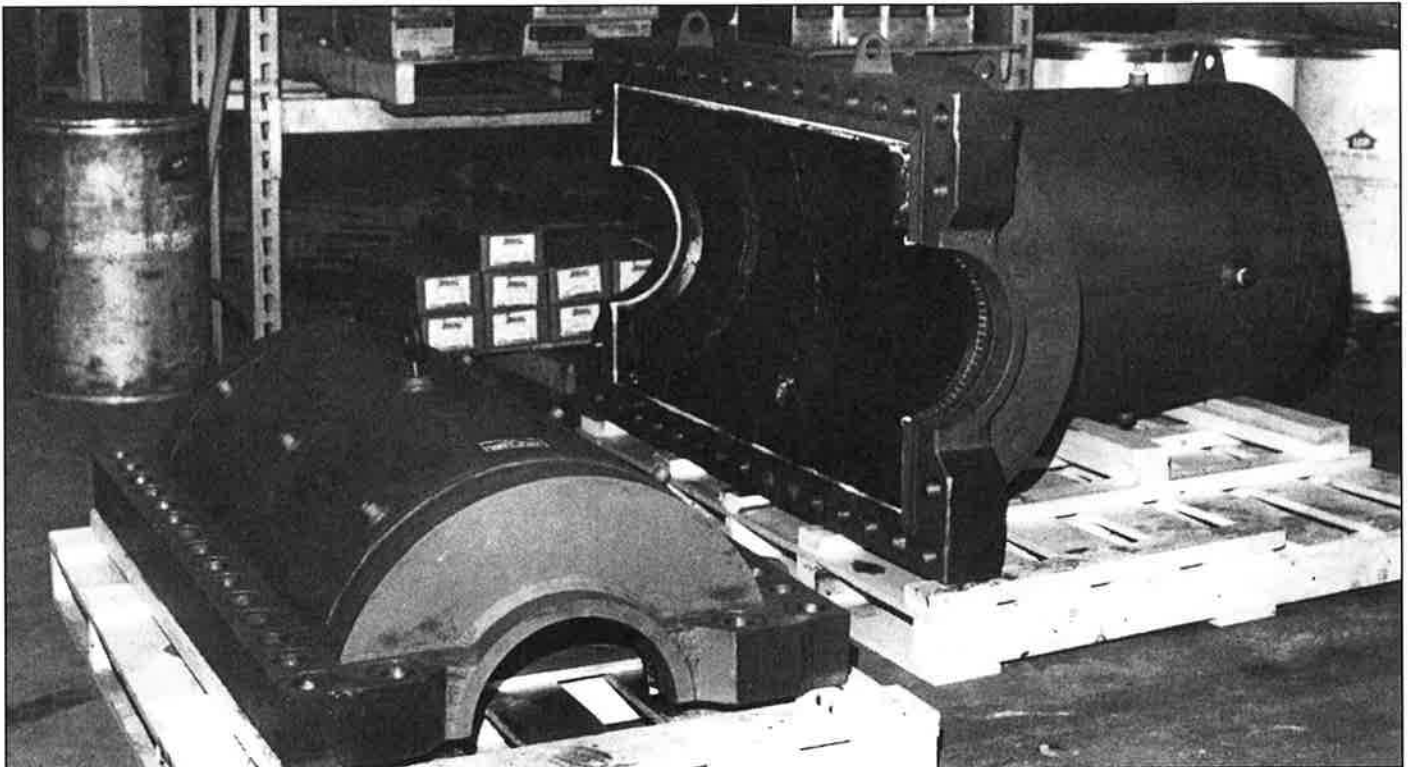
Plidco Special Oversleeve to enclose a 12" 600# gate valve operating at 650 psi working pressure, 750° F. superheated steam. The company seal welded the entire fitting.

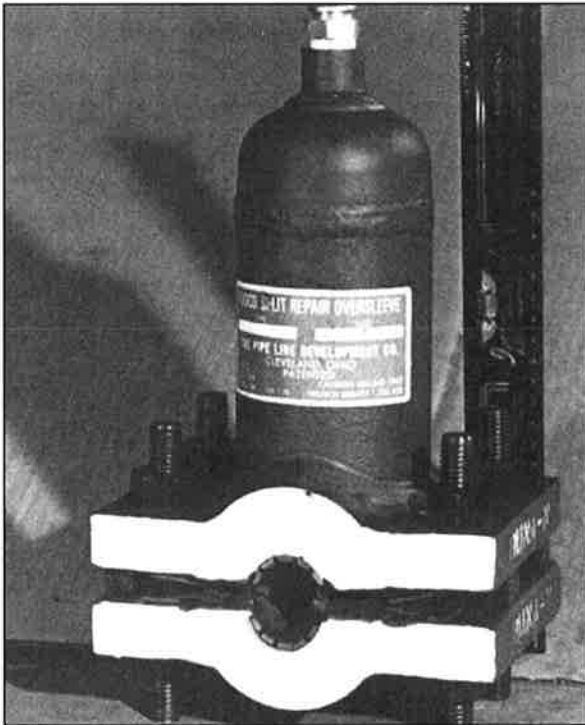
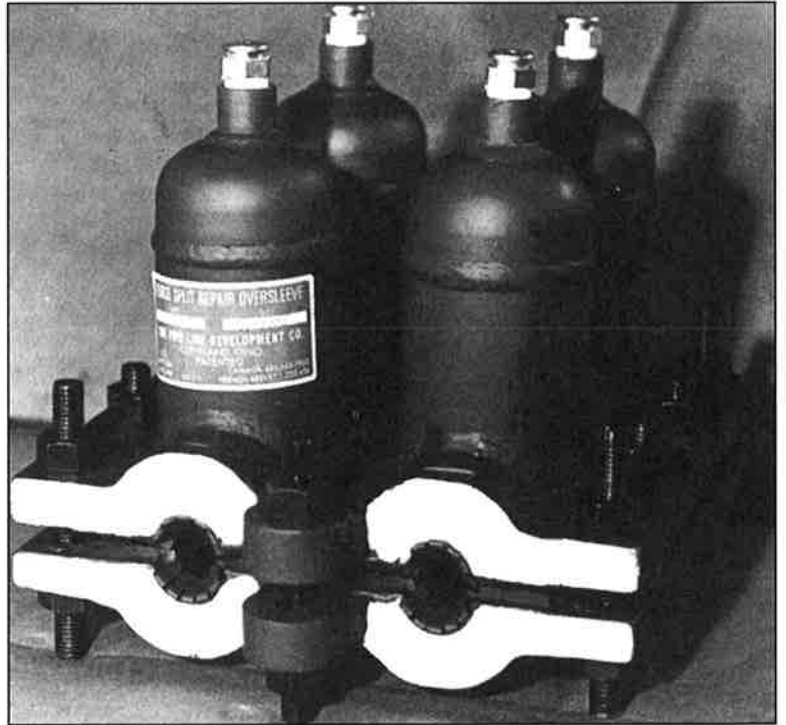
Special Plidco Valve Oversleeve to encapsulate a 3/4" valve and a bank of four 3/4" valves, operating at 293°C. (559°F)

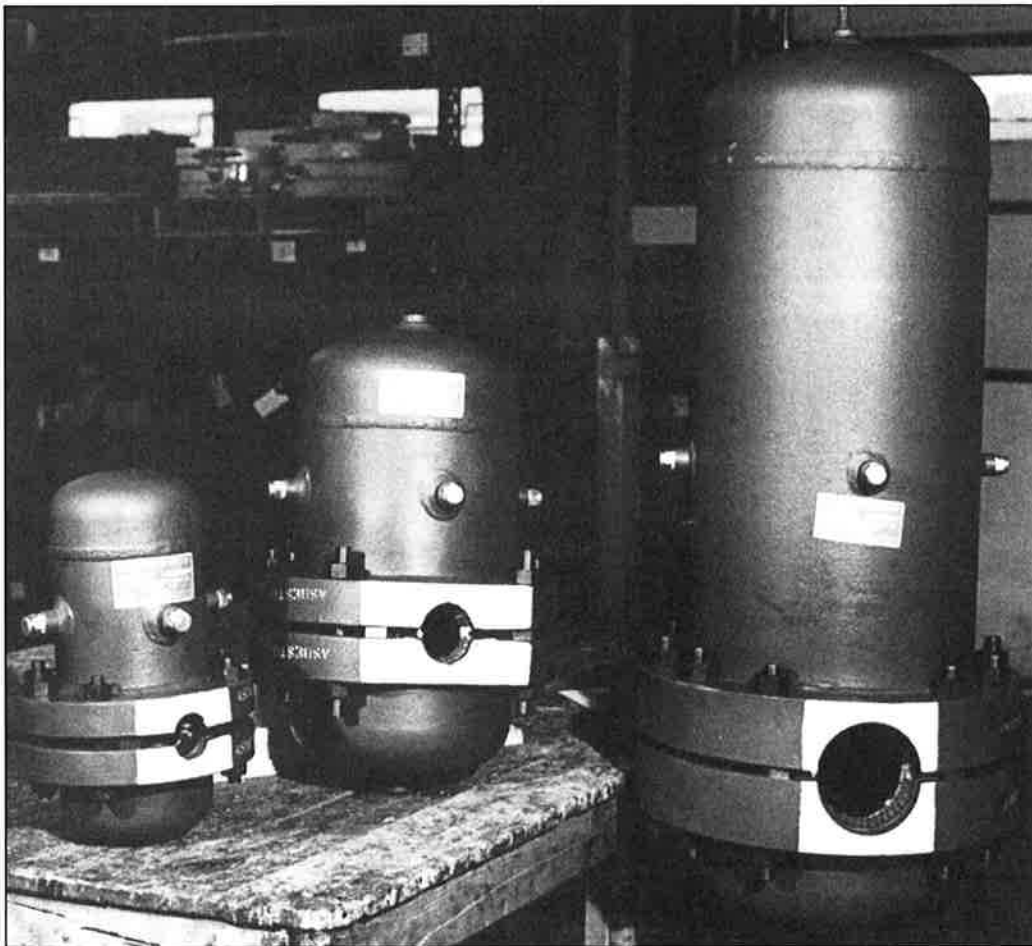
Special Plidco Valve Oversleeve to encapsulate 34mm, 60.5mm and 114.3mm valves, operating at 275 psig.

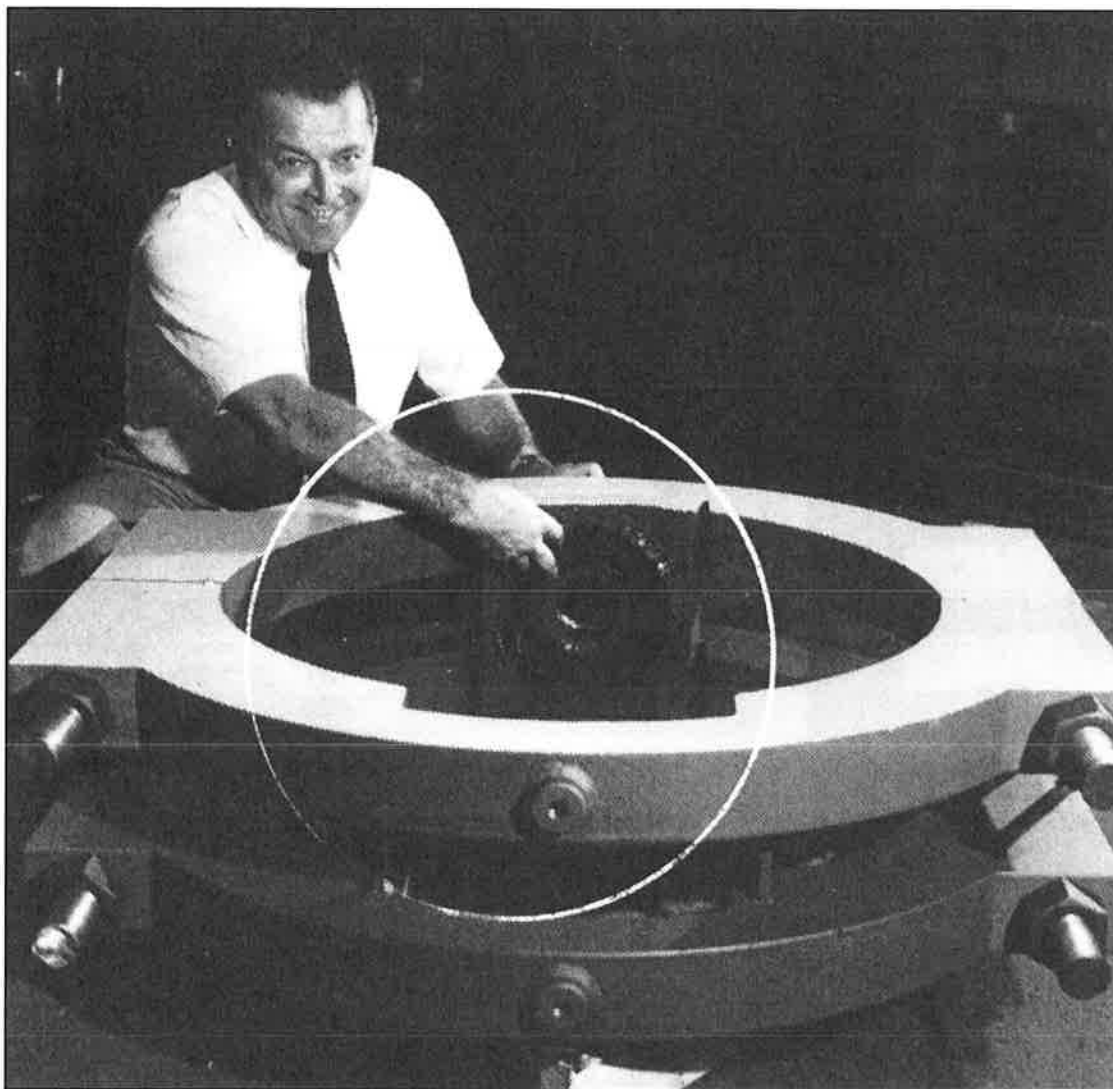
Designed to seal around leaking nipple on a wellhead located in an ethylene storage field.

Designed for 1600 psig working pressure.

The special dome construction has a double row of packing. Sealant was injected between packing, allowing for monitoring of leak in the dome.

Pointing out the dome with a double row of packing to enclose the nipple.

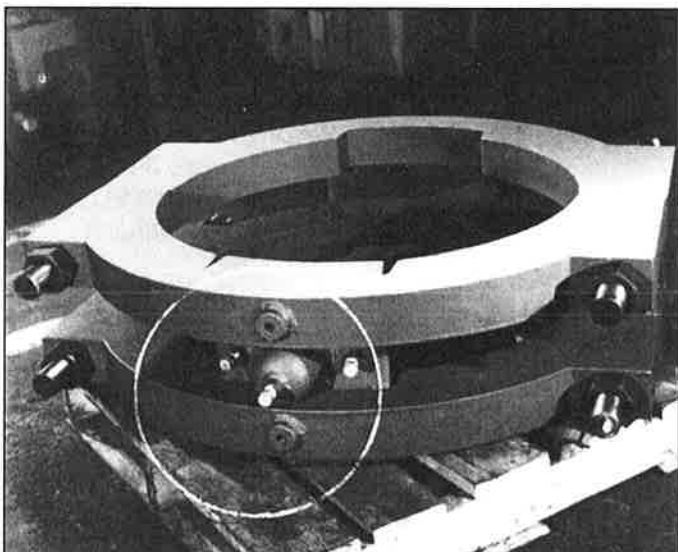
Dome construction and buttonhead fittings for injecting sealant.

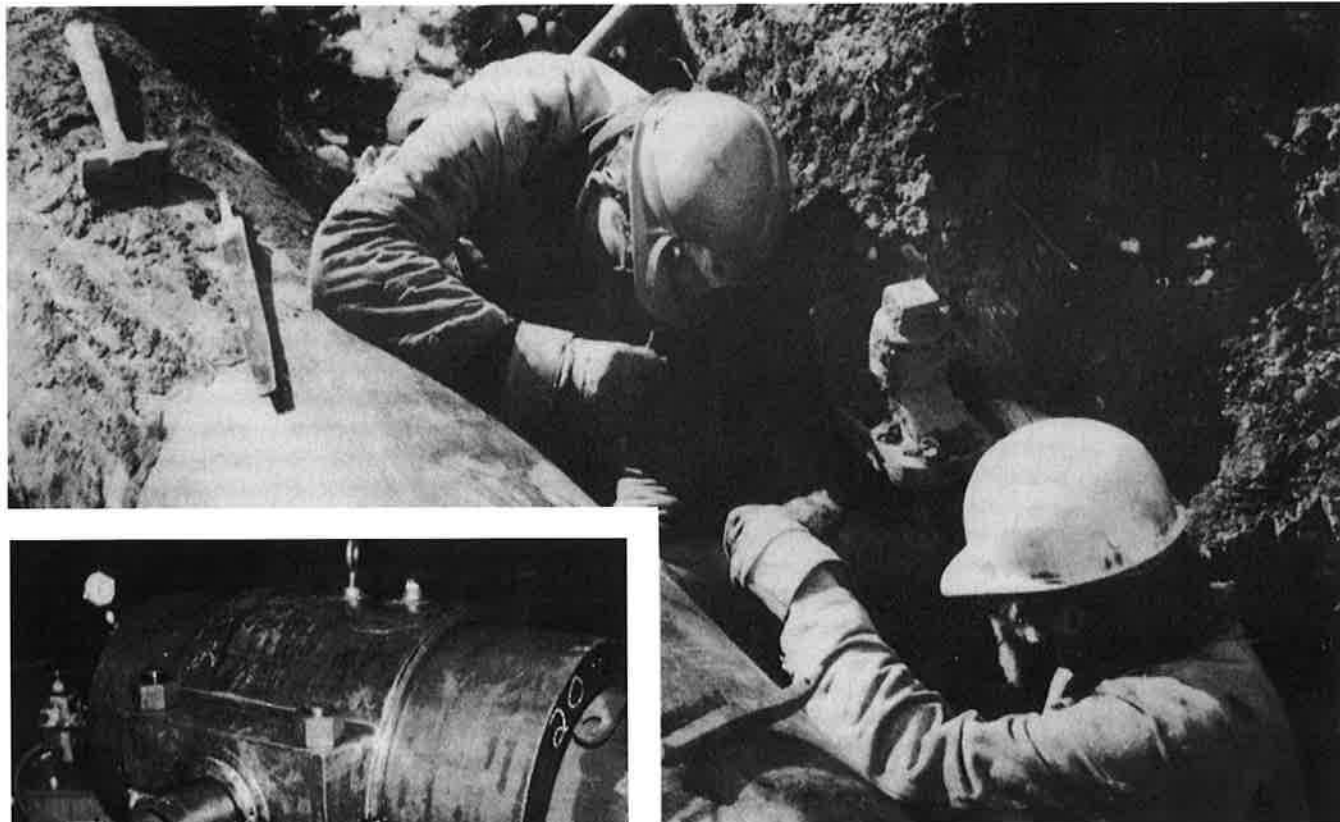
The protective coating was removed from the leaking 20-in. main, using non-ferrous hammers to reduce the danger of sparks, prior to installation of the special repair fitting.

The special repair fitting was fabricated by PLIDCO in just 3 days from completion of drawings to hydrostatic testing of the completed unit.

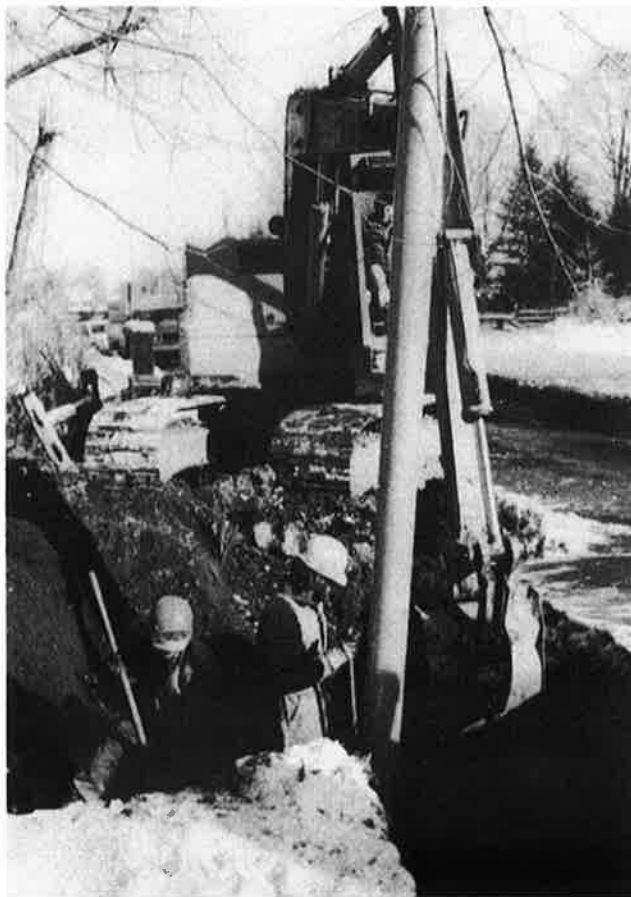
Upon excavating the site, they found a leak on a 20-in. trans-

mission line where a 4-in. welded tee connection with a reinforcing pad had recently been installed. The 4-in. connection led to side gate and pressure reducing station. The line was operating at 450 psi.

Leaking gas was safely vented to the atmosphere via this pipe as East Ohio Gas officials pondered the repair options available.

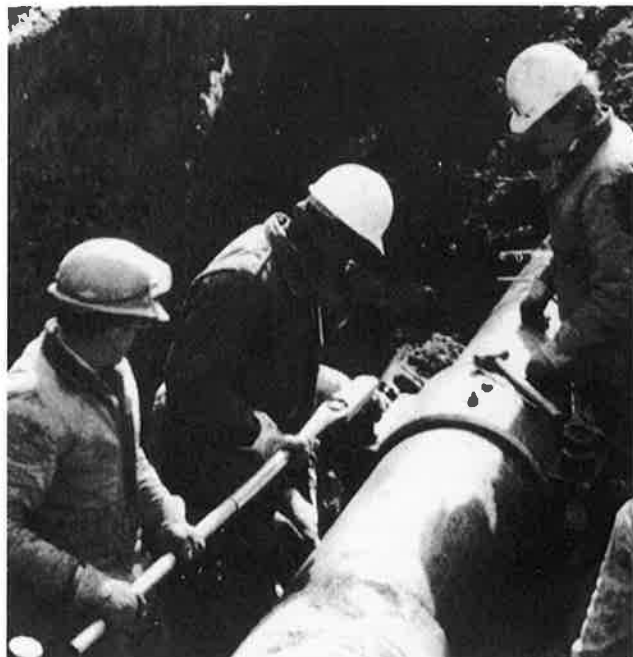
Contractor crew tightens the bolts on the special PLIDCO repair fitting with a torque wrench to ensure proper sealing of the leaking 20-in. main.

After the halves were secured, a torque wrench was used to tighten all studs and nuts to the recommended torque.

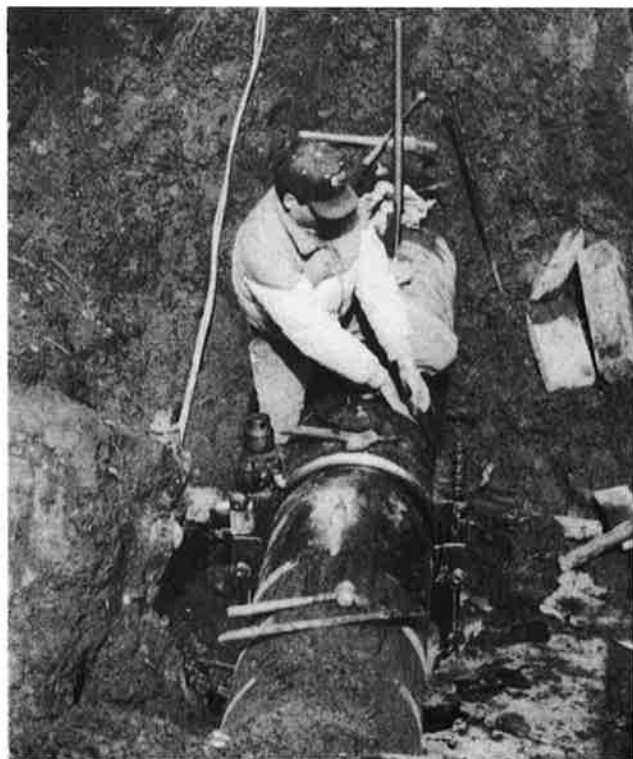
The completed installation of the special repair fitting encapsulated the leaking section of 20-in. main without requiring the line to be taken out of service.

**Welding.** In order to make the repair permanent, the installation was welded.

First, the circumferential ends of the 20-in. sides of the fitting were fillet welded to the pipe. An alternating welding pattern was used to preclude any heat build-up that might damage the fitting's seal and to reduce stresses during welding.

Fillet welds were then made on the 4-in. branch. The fitting's side bars, studs and nuts were seal-welded.

After welding, soap tests were conducted. Magnetic particle inspection was performed to confirm weld integrity.
